**NL INDUSTRIES/TARACORP SUPERFUND SITE GROUP**  
**Leed Environmental, Inc.**  
**Van Reed Office Plaza**  
**2209 Quarry Drive, Suite C-35**  
**Reading, PA 19609**  
**Telephone: (610) 670-7310**  
**Facsimile: (610) 670-7311**

**Re: NL Industries/Taracorp Superfund Site; Granite City, Illinois**  
**First 2017 Semi-Annual Operation and Maintenance Inspection (May 2017)**

**NL Industries/Taracorp Superfund Site  
Inspection Log - Operation and Maintenance**

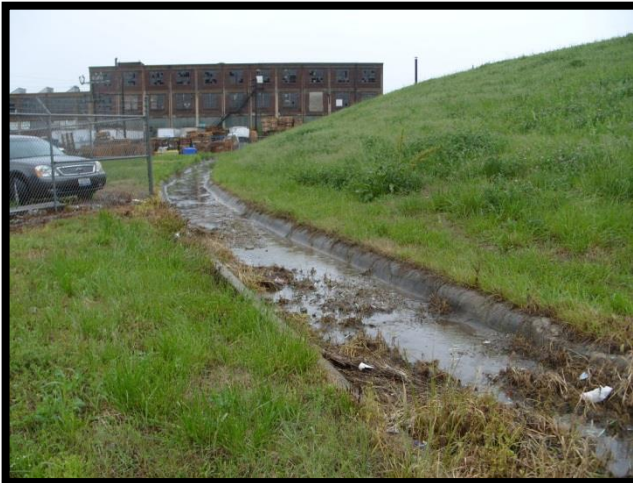
Photograph 41: Southern side of Taracorp pile (view west).

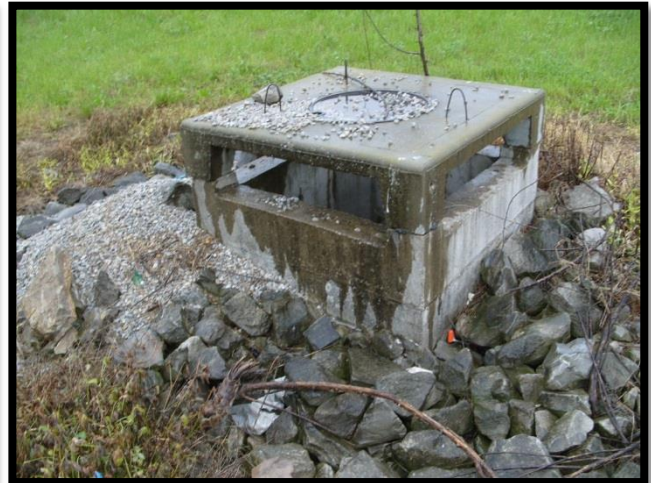
Photograph 42: Stormwater outlet.

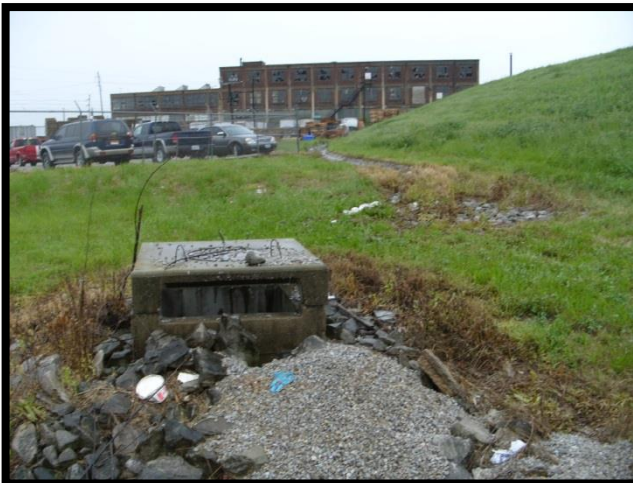
Photograph 43: Stormwater outlet.

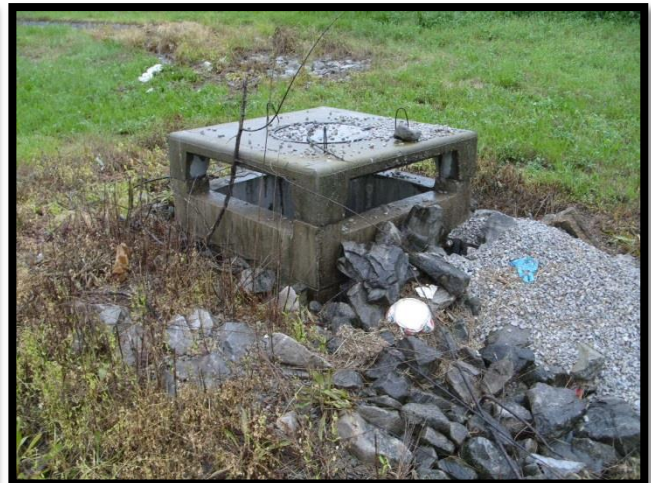
Photograph 44: Stormwater outlet.

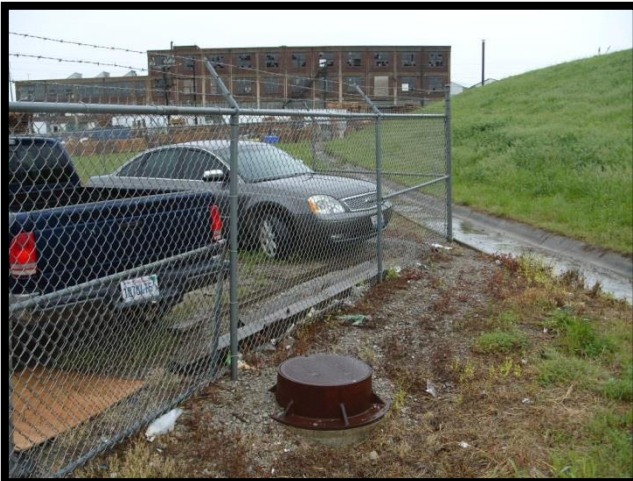
Photograph 45: Stormwater manhole near fence.

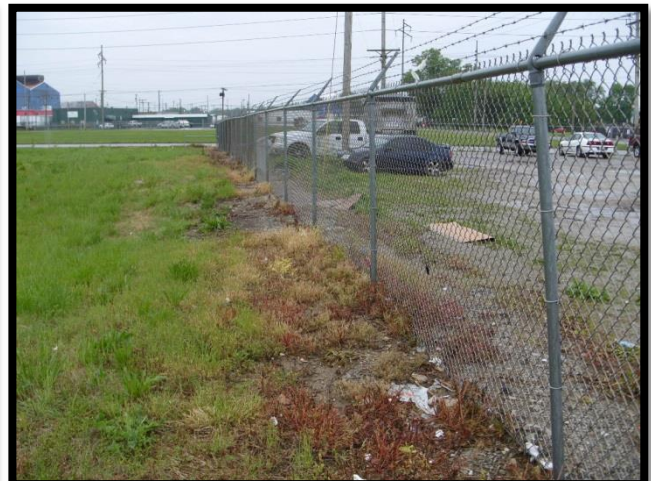
Photograph 46: Vegetation and fence near former Rich Oil facility (view toward State Street).

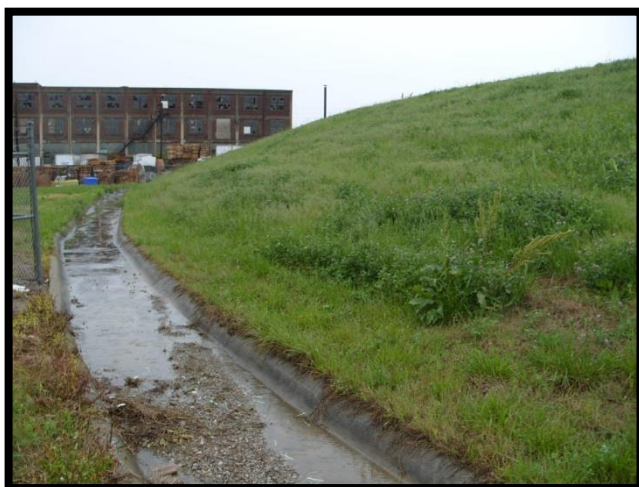
Photograph 47: Vegetation, southern side of Taracorp pile cap.

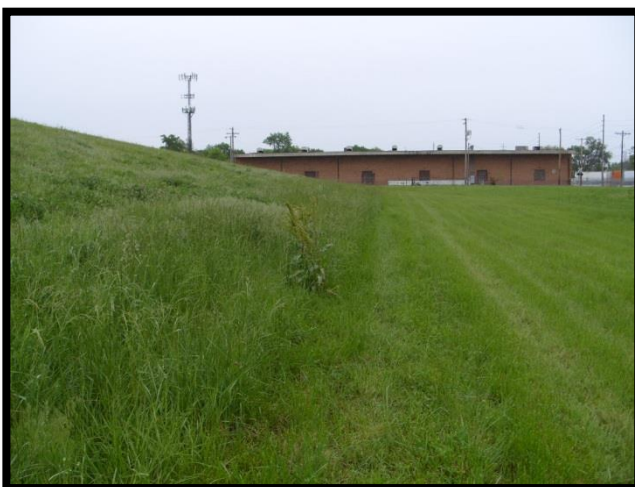
Photograph 48: Vegetation, eastern side of Taracorp pile cap.

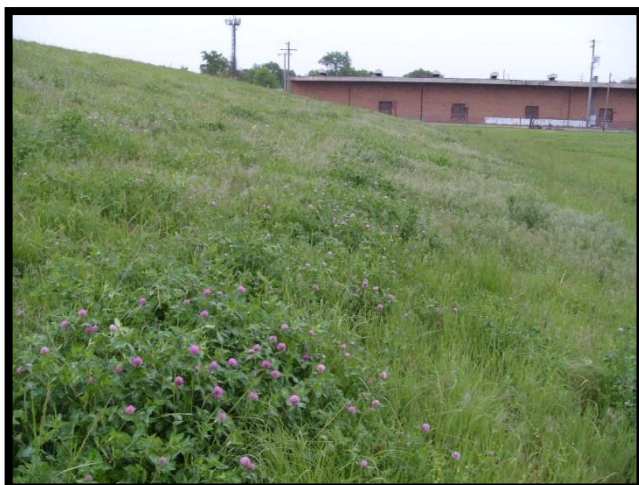
Photograph 49: Crown vetch, eastern side of Taracorp pile cap.

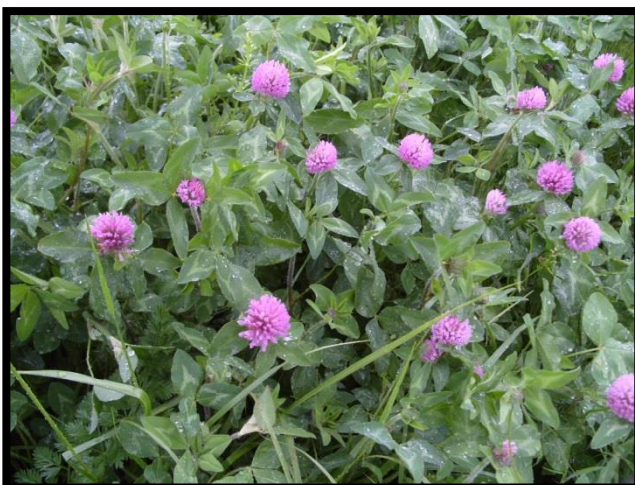
Photograph 50: Crown vetch, eastern side of Taracorp pile cap.

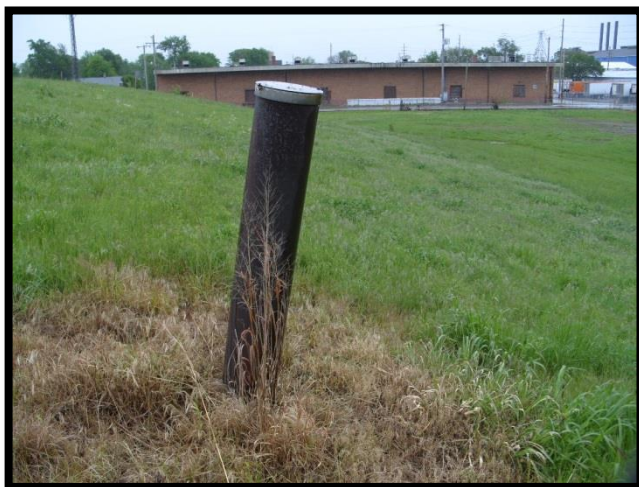
Riser pipe and locks	Yes	Riser pipe clean and in good condition. The lid on the riser pipe was locked.	
Leachate levels in sump	No	EWI removed leachate from the sump in June 2014 as part of the five-year review groundwater monitoring event.	
Necessary sampling activities	No		
Necessary leachate disposal	No		
Comments

Photograph 51: Leachate riser pipe.

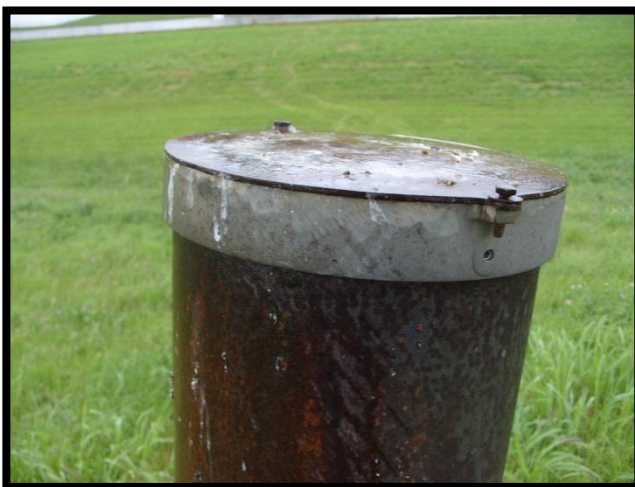
Photograph 52: Locked lid on leachate riser pipe (locked lid installed fall 2007).

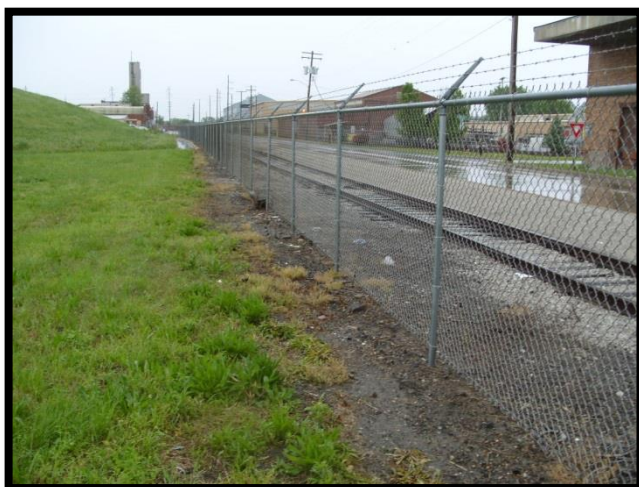
Photograph 53: Vegetation near fence along railroad tracks.

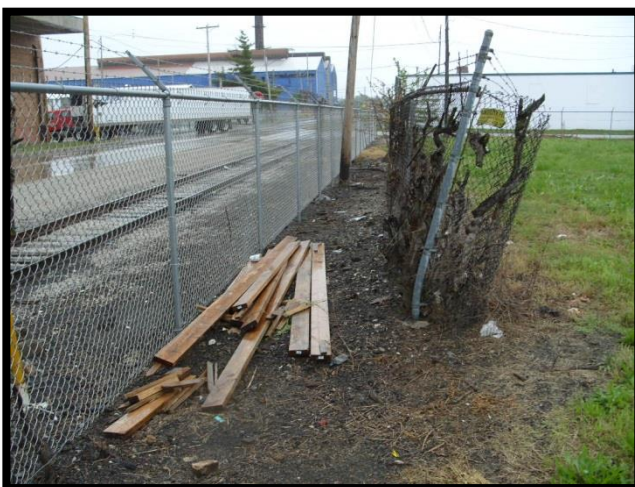
Photograph 54: Older and newer fence near former BV&G Truck Service buildings along railroad tracks (view northeast).

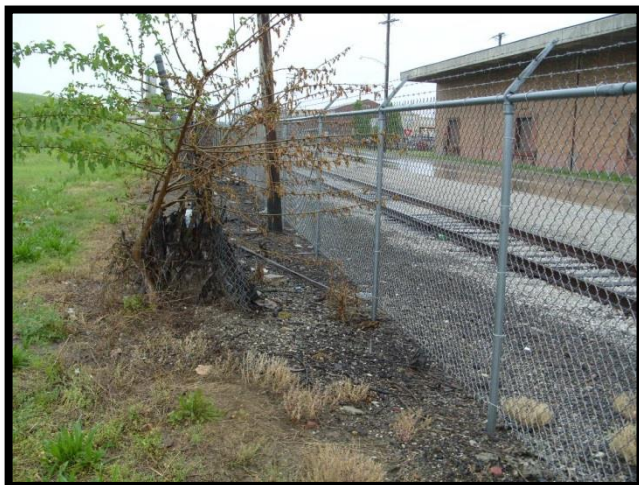
Photograph 55: Older and newer fence near former BV&G Truck Service buildings along railroad tracks (view northwest).

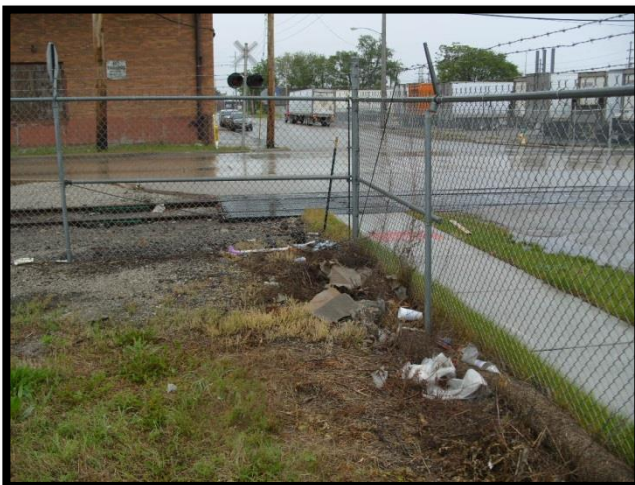
Photograph 56: Inside fence, corner of State Street and 16<sup>th</sup> Street.

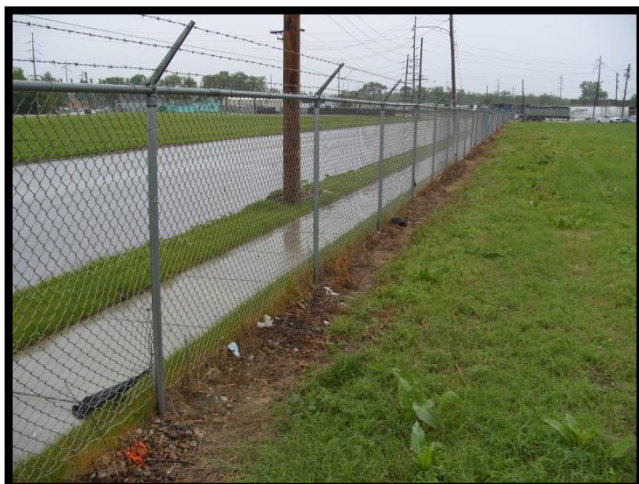
Photograph 57: Inside fence, view south along State Street.

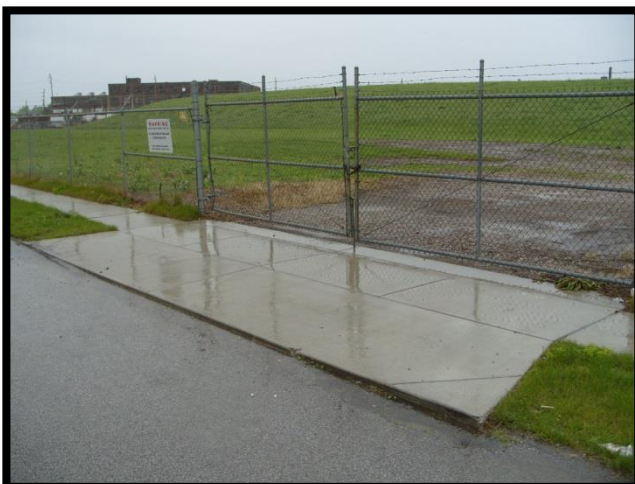
Photograph 58: Concrete entranceway gate near 16<sup>th</sup> and State Streets.

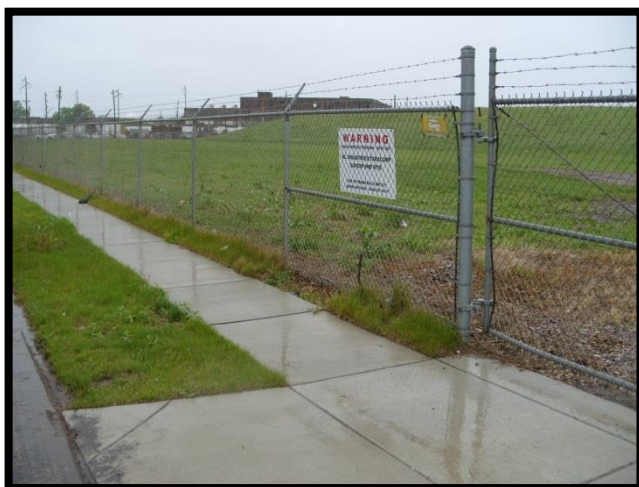
Photograph 59: Fence, grass, and sidewalk along State Street.

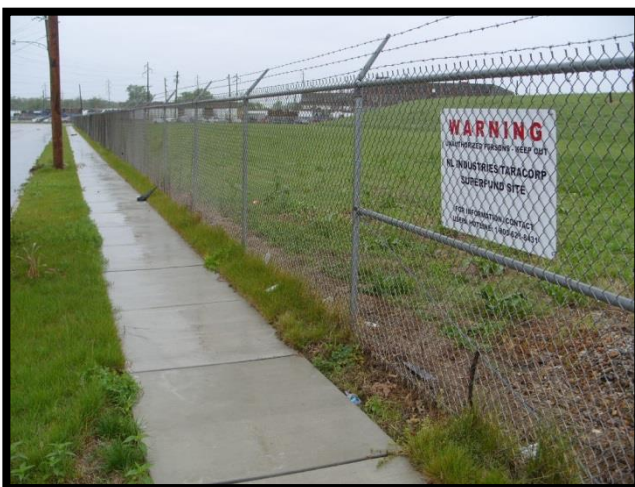
Photograph 60: Fence, grass, and sidewalk along State Street.

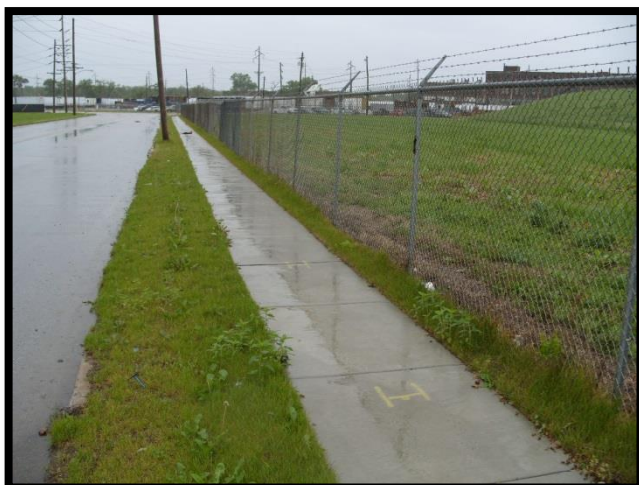
Photograph 61: Fence, grass, and sidewalk along State Street.

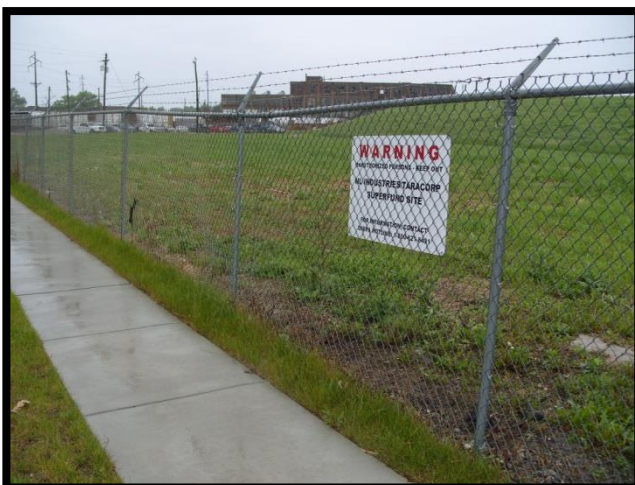
Photograph 62: Warning sign along State Street.

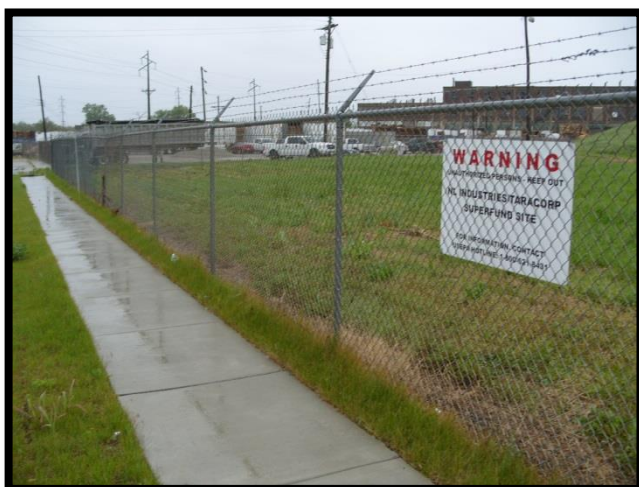
Photograph 63: Warning sign along State Street.

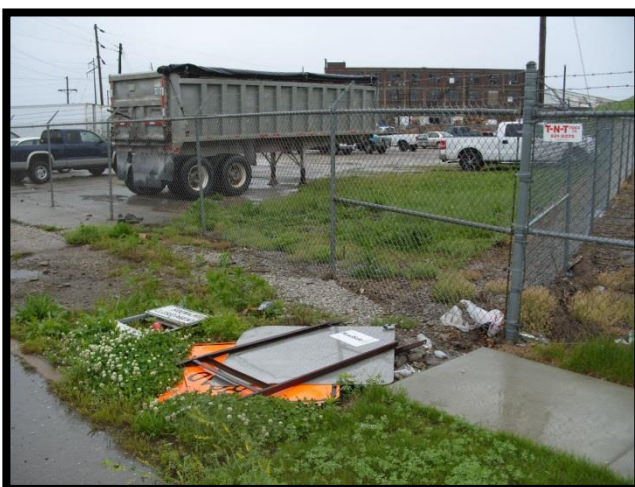
Photograph 64: Southern end of concrete sidewalk on 1555 State Street property (adjacent to former Rich Oil property).

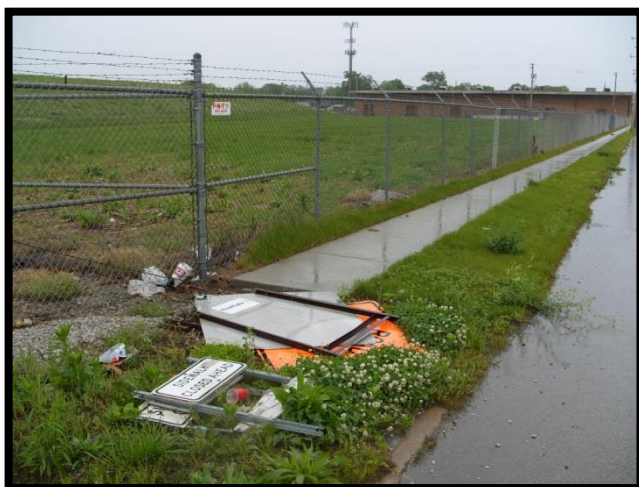
Photograph 65: Southern end of concrete sidewalk on 1555 State Street property (adjacent to former Rich Oil property).

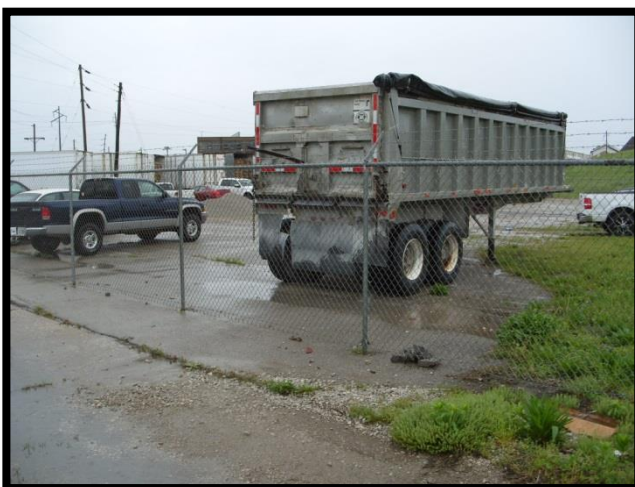
Photograph 66: Former Rich Oil property.

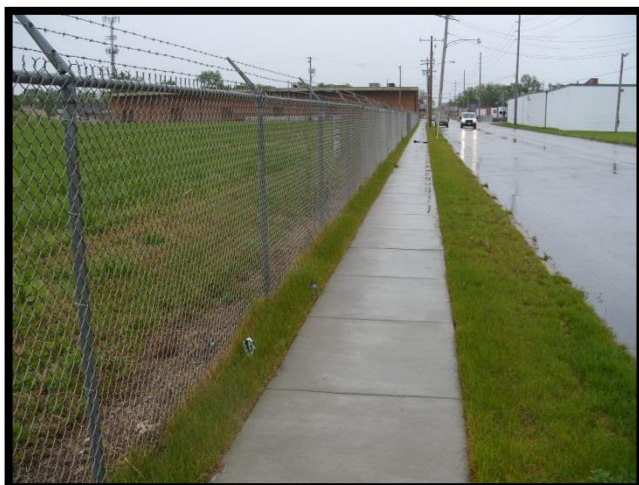
Photograph 67: Fence, grass, sidewalk along State Street.

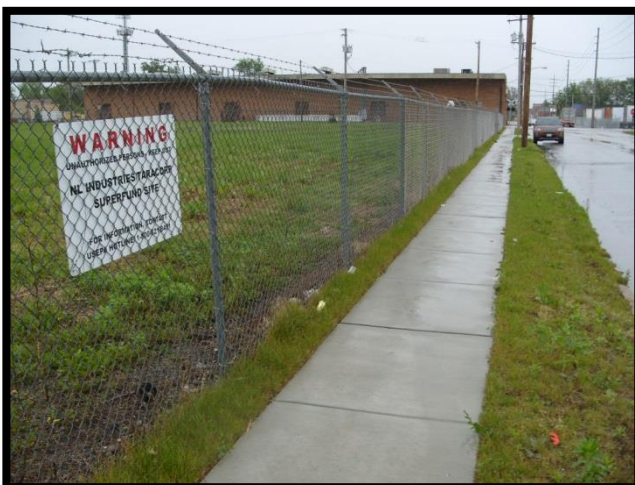
Photograph 68: Fence, grass, sidewalk along State Street.

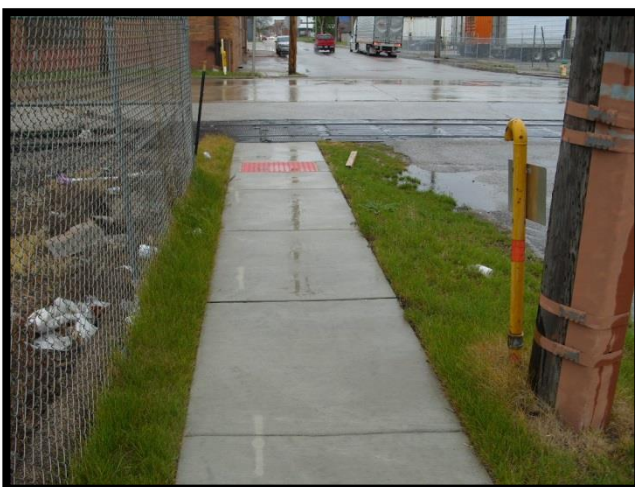
Photograph 70: Fence, grass, sidewalk along State Street.

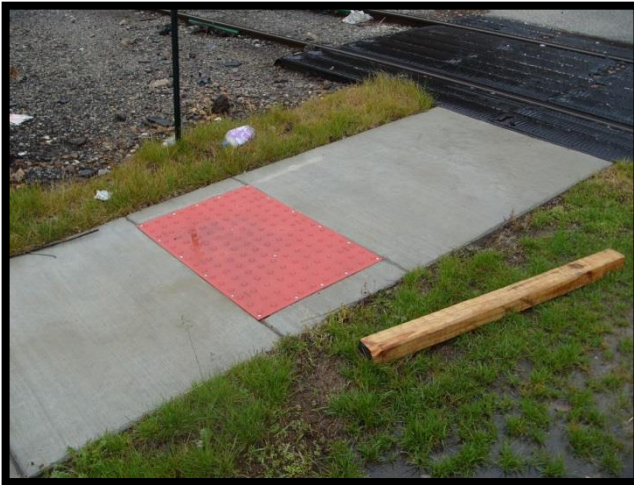
Photograph 71: End of sidewalk along railroad tracks.

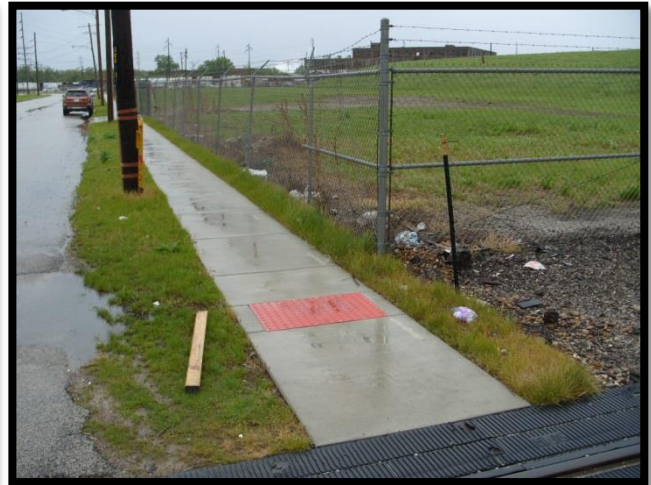
Photograph 72: End of sidewalk along railroad tracks.

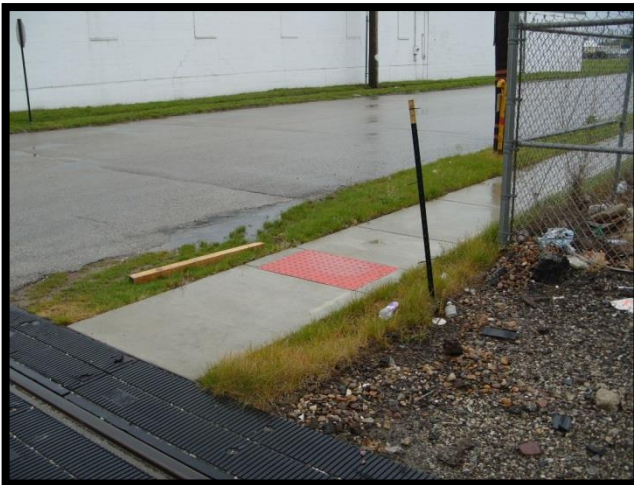
Photograph 73: End of sidewalk along railroad tracks.

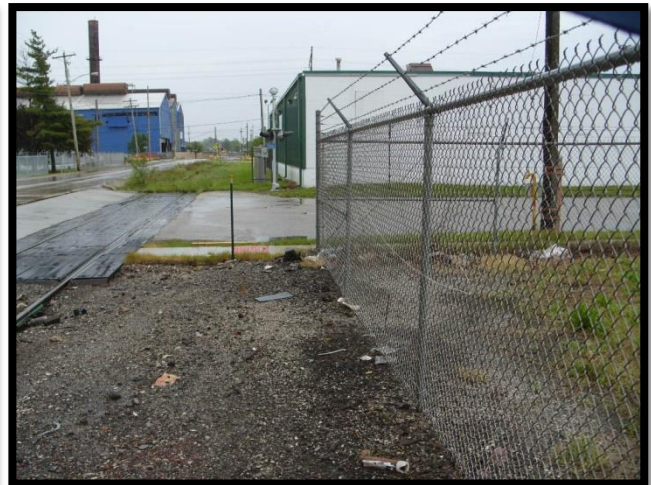
Photograph 74: Fence at 16<sup>th</sup> and State Streets.

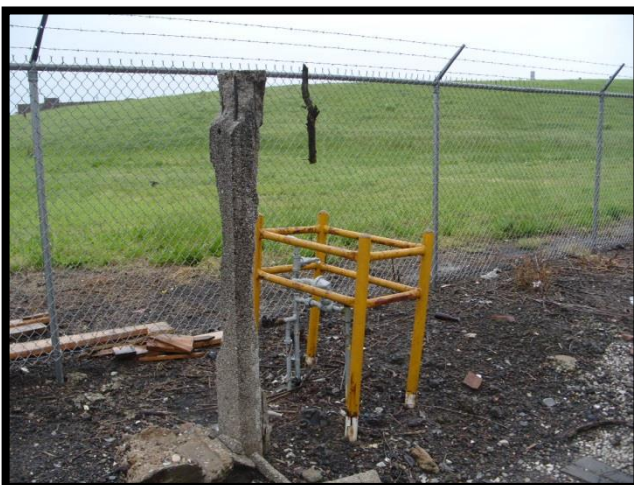
Photograph 75: Gas utilities along railroad tracks.

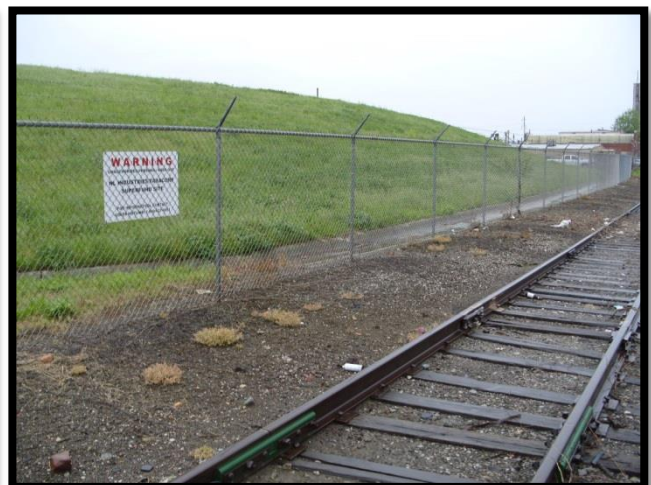
Photograph 76: Warning sign on fence along railroad tracks near 16<sup>th</sup> Street and Edison Avenue.

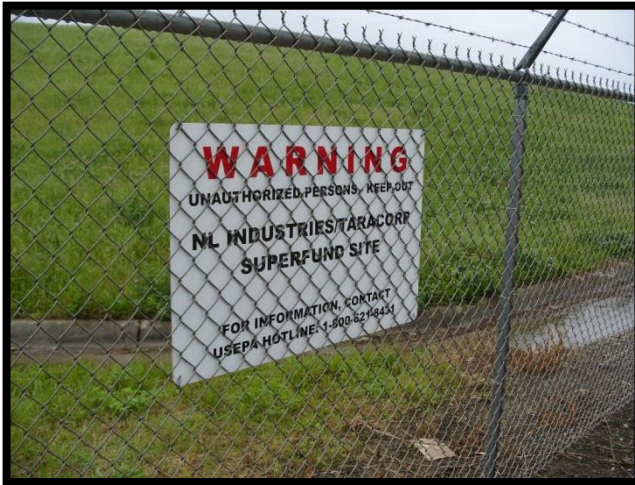
Photograph 77: Warning sign on fence along railroad tracks near 16<sup>th</sup> Street and Edison Avenue.

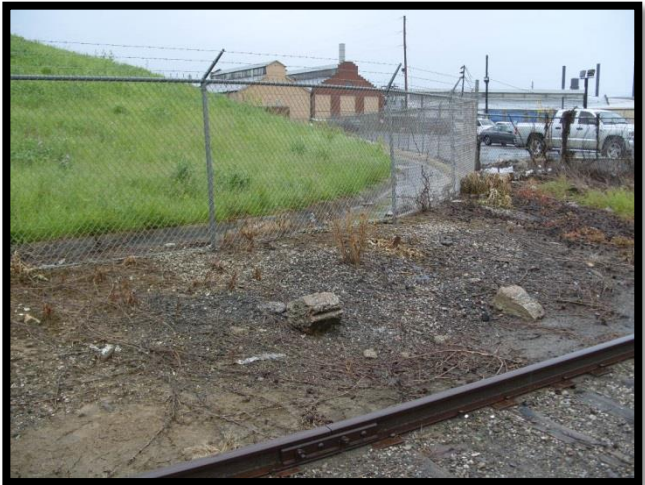
Photograph 78: Fence and vegetation along railroad tracks and 16<sup>th</sup> Street.

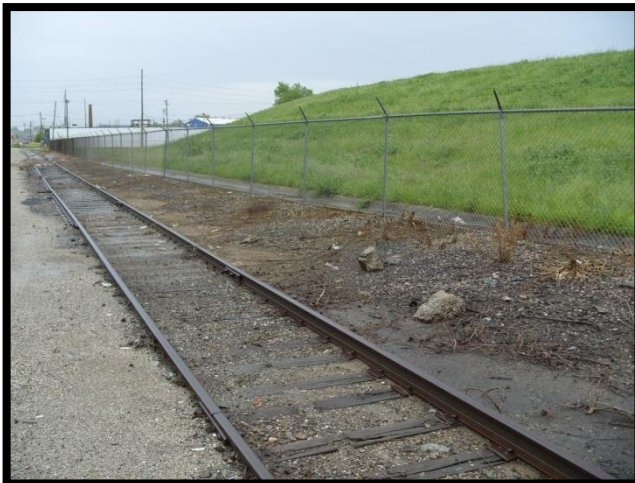
Photograph 79: Fence and vegetation along railroad tracks and 16<sup>th</sup> Street.

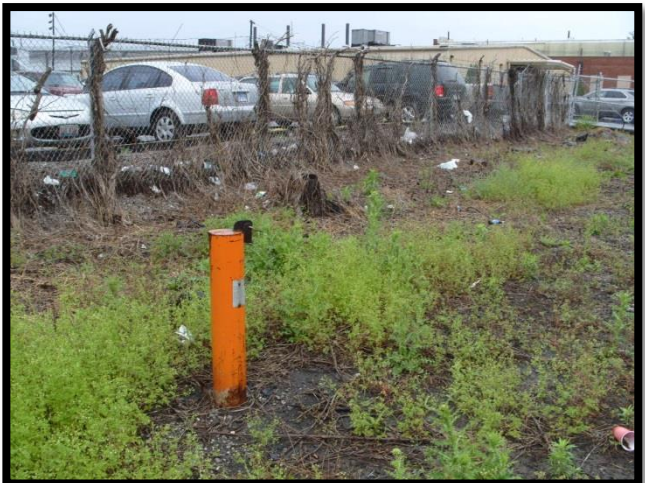
Photograph 80: Monitoring well, fence, and vegetation along railroad tracks and 16<sup>th</sup> Street.

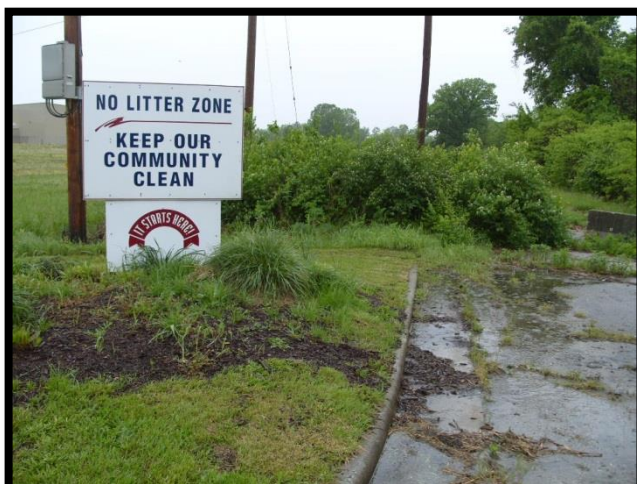
Photograph 1: Schaeffer Road property.

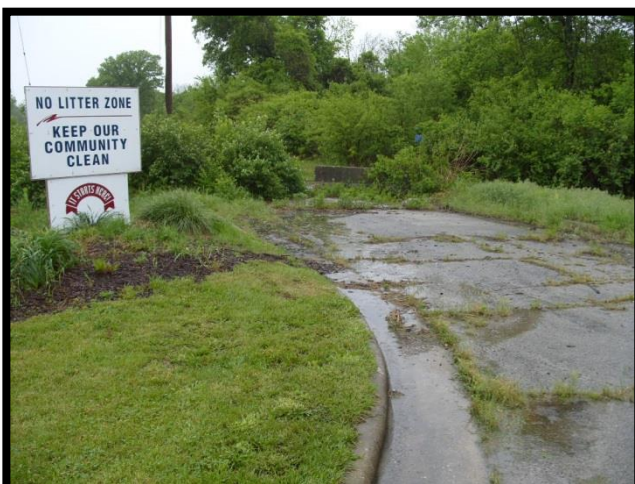
Photograph 2: Schaeffer Road property.

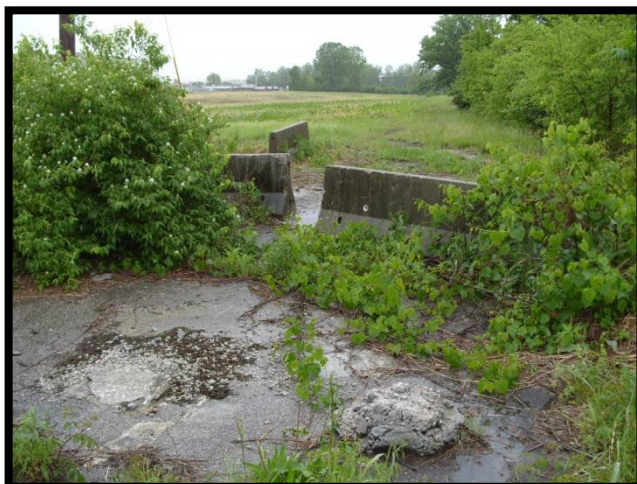
Photograph 3: Schaeffer Road property.

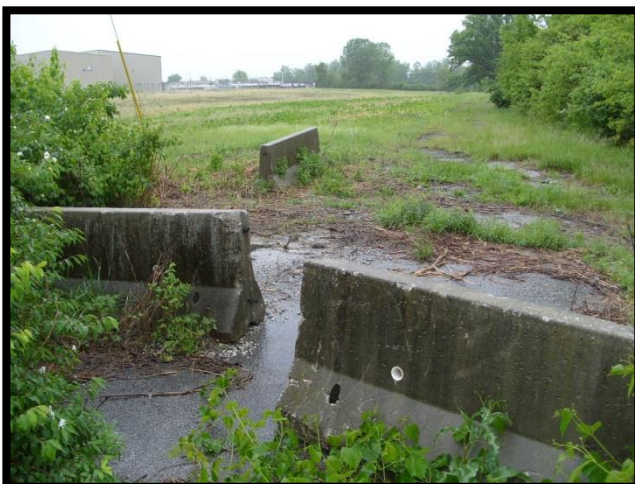
Photograph 4: Schaeffer Road property.

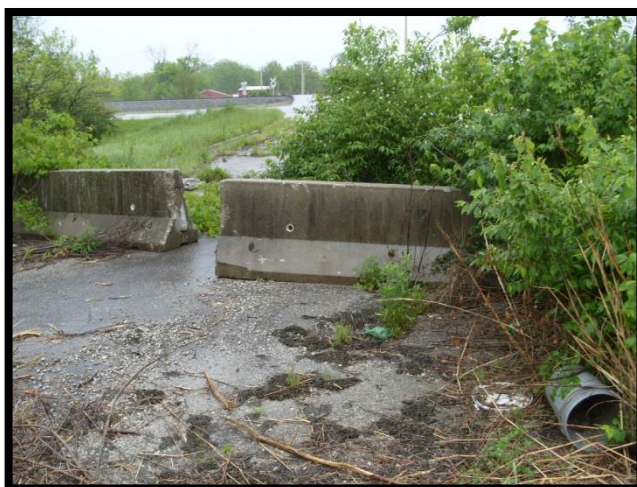
Photograph 5: Schaeffer Road property.

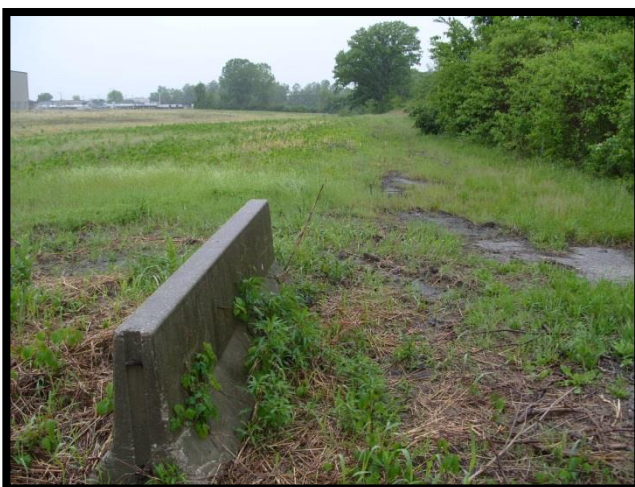
Photograph 6: Schaeffer Road property.

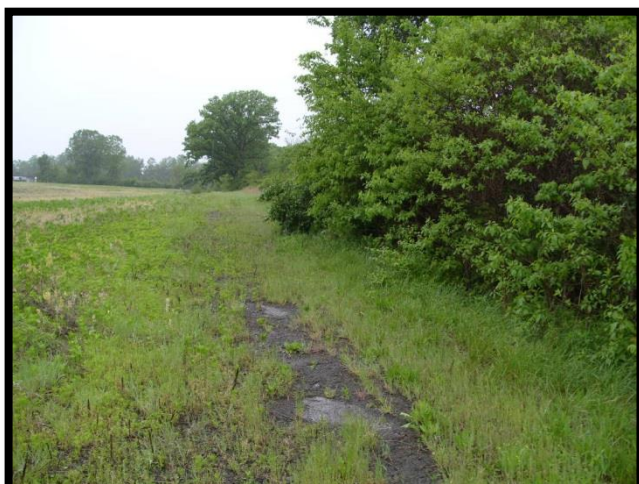
Photograph 7: Schaeffer Road property.

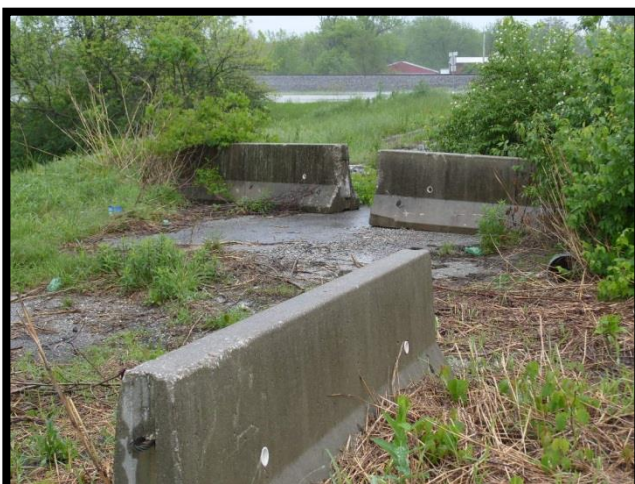
Photograph 8: Schaeffer Road property.

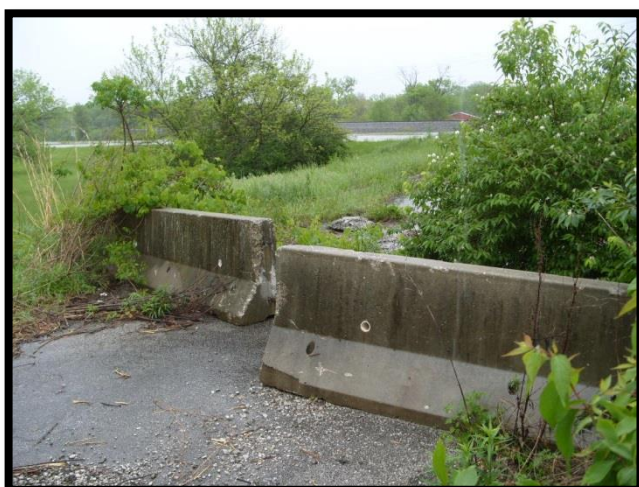
Photograph 9: Schaeffer Road property.

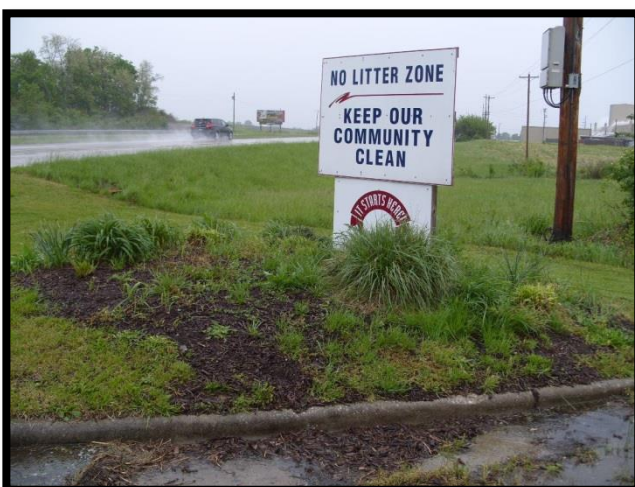
Photograph 10: Schaeffer Road property.

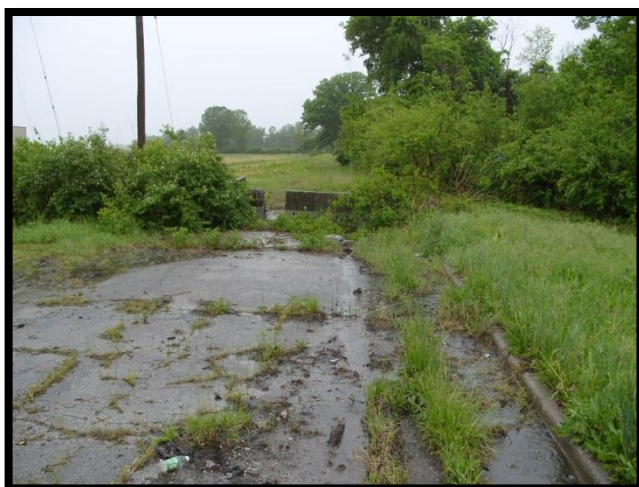
Photograph 11: Schaeffer Road property.

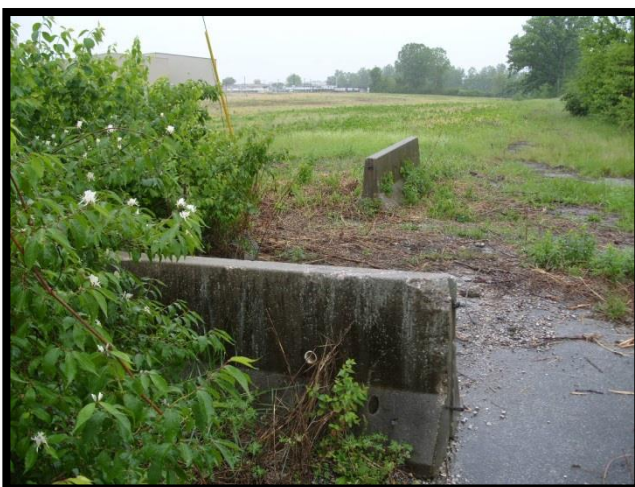
Photograph 12: Schaeffer Road property.

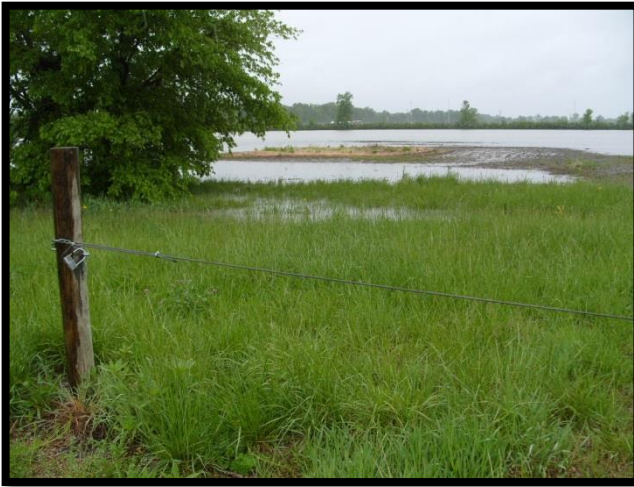
Photograph 1: Sand Road property (view from entrance).

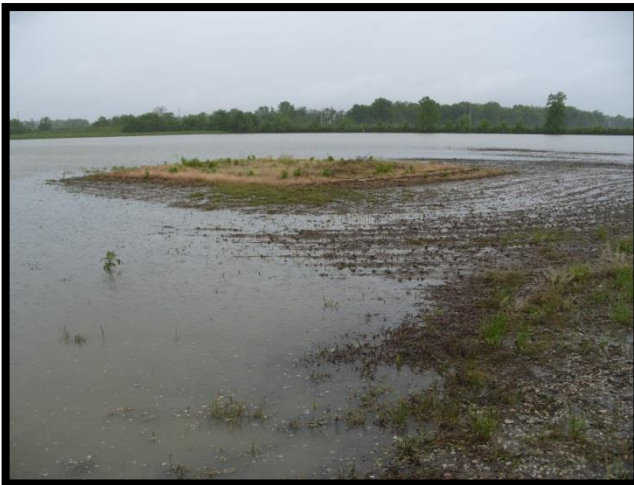
Photograph 3: Sand Road property.
